### GEOLOGIC REPORT DRAFT

Fairview

Jefferson County, Colorado

Regarding: Geological Report – Fairview  
Jefferson County, Colorado

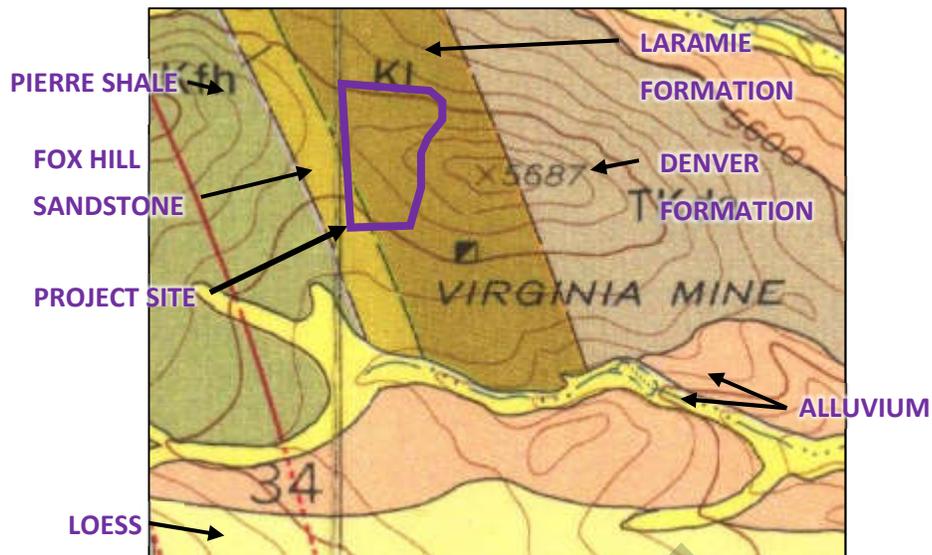
The figure below shows the mapped geology in the site vicinity.

**FIGURE 3.1** – Mapped geology in the project vicinity. The project site is mapped as shallow Fox Hills Sandstone (Kfh/Kf) and Laramie Formation (Kl). Thin loess and alluvium deposits are present regionally. Modified from Scott, G.R., 1962.

The geology in the area is mapped as clay, silt, sand, and gravel of the Pleistocene-aged Slocum and Verdos Alluvium and sandy and silty loess overlying bedrock. Both the Pleistocene-aged alluvium and loess are wide-spread units found on broad slopes regionally sloping eastwards towards river basins. Modern alluvium, generally comprised of silt, sand, and gravel, are found in drainage channels.

The Lower Member of the Laramie Formation underlies much of the site and is described as tan to yellowish orange, sandstone with iron concretions and dinosaur fossils, claystone, and coal. The Upper Member is predominantly claystone and clayey sandstone. Both claystone and coal in the Laramie Formation were historically mined in the Colorado Front Range. The Virginia Mine, located immediately east of the project site and below ground, is an example of historic coal stope mining. While the bedrock units were originally deposited horizontally, the uplift of the Rocky Mountains caused the bedrock units to tilt as much as 50 degrees from horizontal to the east-north-east. A nearby sandstone outcrop has a mapped dip of 54 degrees towards the northeast. The Fox Hills Sandstone is mapped as underlying the southwestern corner of the project site and is described as yellowish-orange, massive to thinly-bedded, cross-bedded, and friable fine-grained sandstone and interbedded, dark, and olive-gray shale and claystone.

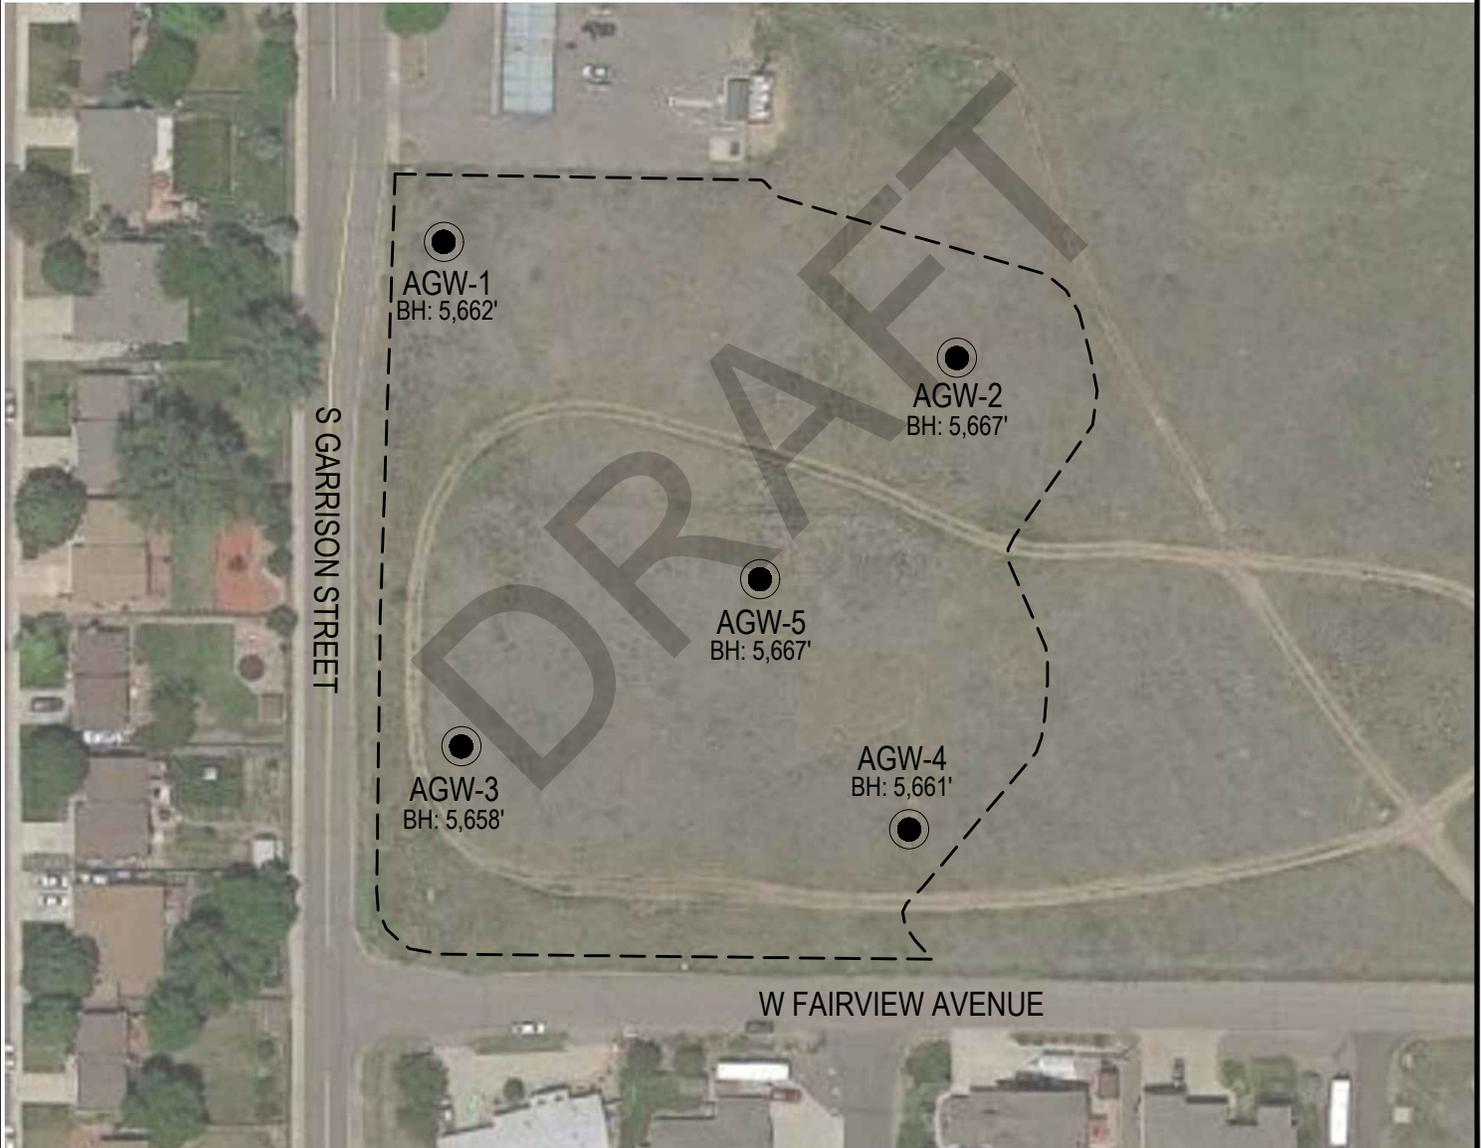
BORING LOCATION MAP

1. BOREHOLES WERE STAKED AND SURVEYED BY OTHERS
2. BH = BOREHOLE ELEVATION IN FEET ABOVE MSL

<u>Figure Number</u>	<u>Title</u>
1	Site Vicinity and Boring Location Map
2	Bedrock Elevation and Surficial Soils Isopach Map

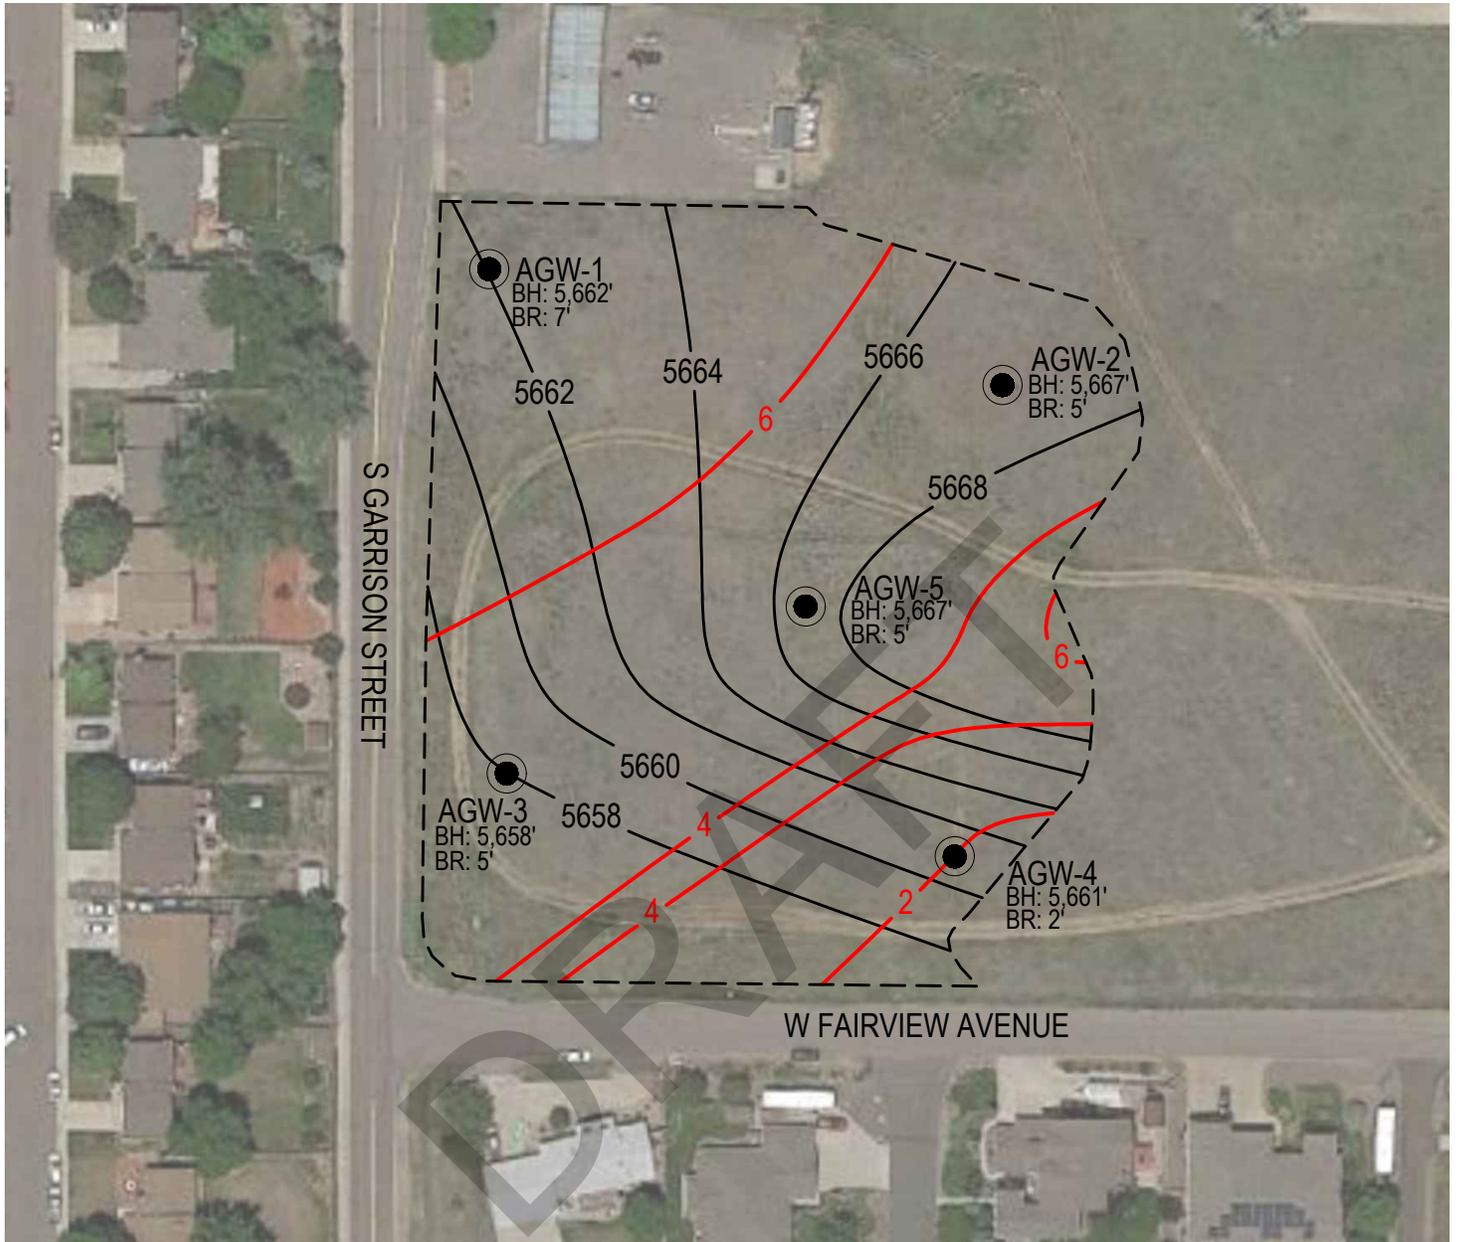
- APPROXIMATE BORING LOCATION
- SITE BOUNDARY
- BEDROCK ELEVATION CONTOUR (FEET)
- SURFICIAL SOILS ISOPACH CONTOUR (FEET)

1. Ground conditions were characterized as topsoil and clay overlying shallow claystone and sandstone bedrock less than 10 feet below existing ground surface. The surficial materials consist of stiff to very stiff clay. Bedrock consists of hard to very hard interbedded claystone and sandstone. Existing geologic maps indicate loess and alluvium overlie northeast-dipping Laramie Formation and Fox Hills Sandstone. The exact dip of the bedrock was not obtained during the investigation; however, geologic mapping suggests approximately 54 degrees. Groundwater was encountered in only one borehole and within bedrock.
